Excavation support – geotechnical failures in the context of design and execution errors as well as formal and economic conditions

Natalia Maca^{1,*} and Jakub Sierant¹

¹TITAN POLSKA Sp. z o.o., Miłkowskiego 3/801, 30-349 Kraków, Poland

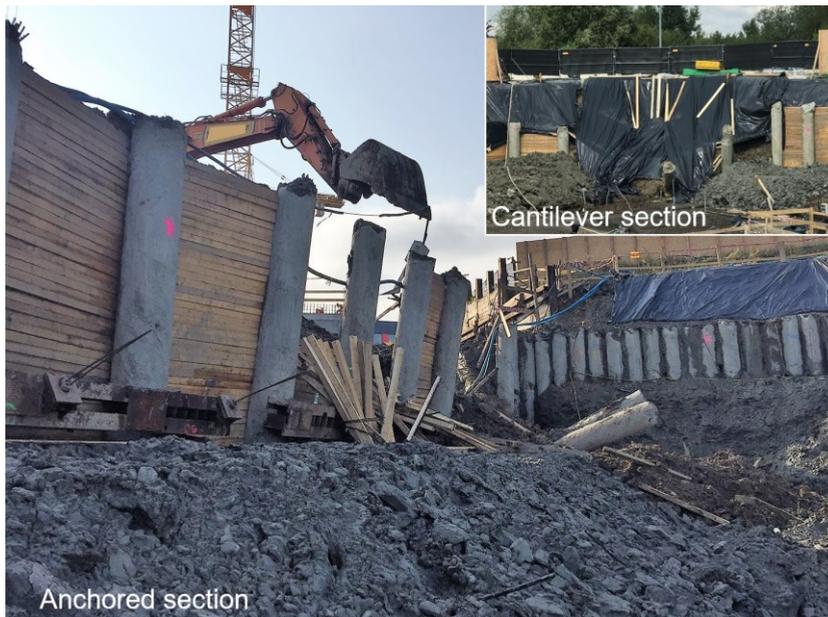
Three weeks after start of earthworks, the largest horizontal displacements of the pile wall head reported by 3 measuring points were up to 63 and 127 mm, significantly exceeding the values specified in the casing design. On that day one section of the soldier pile wall was over excavated to the depth 2.5 m below the anchor level (not installed yet). Once the execution error was detected, the trim was immediately backfilled. In this section the cap beam had not yet been assembled, so the anchors had not been pre-tensioned. The cap beam was assembled two days later. The next day a downpour came and 7 piles tilted or overturned (Fig. 1). The following day, also the shoring with the cantilever soldier pile wall on the other edge of the trench was destroyed over a length of several meters. In this place the earthworks were finished, the lean concrete laid and the installation of the slab reinforcement already started.

Fig. 1. View of the collapsed sections of soldier pile wall.

The analysis of the construction documentation, has shown that damage of the shoring was caused by a combination of several causes, both designing and executive.

The excavation casing has been entirely located in clay described as strongly swelling, thus the designer should have selected sheeting technique preventing access of rainwater and air humidity to such sensitive soils. The soldier pile wall does not meet this requirement, hence swelling clay was exposed to irrigation, as confirmed by the first severe displacement noted during low rainfall and an increase of air humidity. When the rainfall reached 30 mm, the piles were broken. The unfavourable impact of the water was intensified by the slope above the wall, which enabled the flow of rainwater to the backfill space behind the timber infilling. The swelling pressure changed the load pattern adopted in the calculations and significantly increased its value. As a result, displacements quickly exceeded the calculated values. The water moistened also the trench bottom, plastifying clay and reducing the earth resistance.

Furthermore, in the design, according to the EC-7 [1], the effect of swelling soils has not been included in any way. Considering the very high swelling pressure of clays it could be a critical error. In addition, the relatively high effective cohesion of the soil has been assumed up to 60 kPa (according to the old polish standard PN-B-03020 [2]), which substantially exceeds the in-situ and triaxial test results. This value does not take into account the recognized thin gravel layers exposing the clay for negative impact of water, worsening its parameters. It also means that calculation were carried out on the basis of incompatible normative approaches. On the other hand, the ground investigation report (acc. to EC-7 [3]) has been of a very good quality, so these lacks in the calculation are difficult to explain.

It is also worth noting that the piles in the collapsed soldier pile wall have the largest spacing and the weakest reinforcement. This is due to the assumptions of lowering the top of the piles, however the total height of the excavation remained the same as for other sections. Moreover, the cantilever scheme of the wall is dominant, even if total height is up to 8.0 m and spacing the biggest. In such structures, the responsibility of a single structural element is very high and the safety margin minimal, increasing the risk of failure, as happened.

One of the critical factors causing the failure was over excavation of the piles by contractor. The water influence could also be minimized if the contractor would have covered the slope with e.g. watertight sheet.

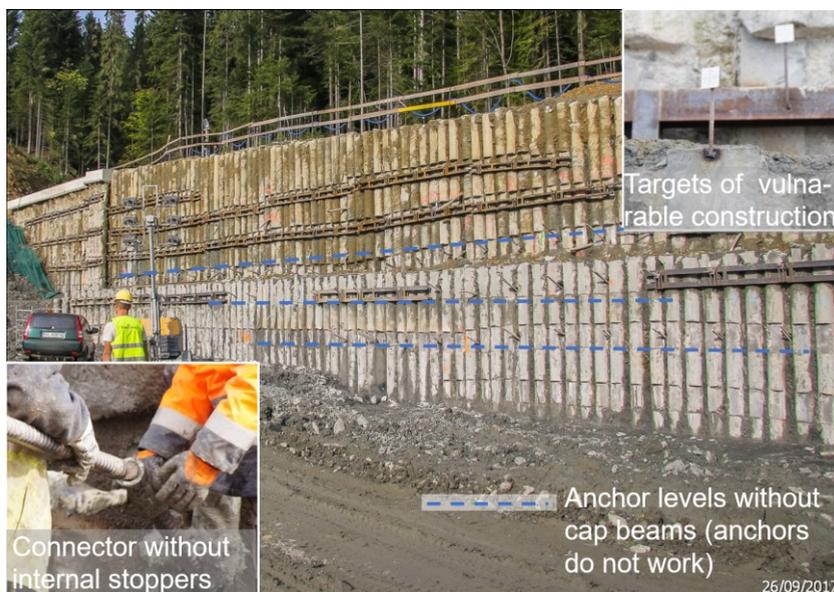
Site visit revealed that project has been executed without the use of observational method, what means without ongoing adaptation of the solution to the actual geological situation assessed continuously and failing to comply the design provisions. The analysis of the situation showed that contractor changed the technology and sequence of operation, what influenced negatively not only the serviceability of the retaining wall, but also gave doubts about its bearing capacity. Some of contractor's arbitrary changes and errors (Fig. 3):

- Switch of the self-drilling technology of the anchorages (micropiles) to the pre-drilling bar anchor without any further modification required by the tender documentation and standard [4], such as: drilling with the casing on the whole length, injection and re-injection from the bottom, bigger diameter of the drill bit etc. In this case, the final bearing capacity comparable to the self-drilling technology (as primarily designed) could not be achieved, not mentioning the diameter and strength of the grout body (because of the lack of stability of the hole), as well as corrosion protection, especially that the bars were installed without any spacers.

- Use of the connectors without internal stoppers to control the screw-in depth of the joint reinforcement so as to guarantee its continuity and load capacity during operation.

- The work should have been carried out in stages, evenly removing soil layers with thickness of one anchor level (ca. 1.5 m), then installing anchors, cap beam and anchor micropile head (so the anchorage could start working) and after 7 days next stage of earthworks could be performed. On site, the earthworks step was up to 2-3 anchor levels, so the wall was excavated up to 6 m without anchoring, what changed dramatically the static scheme.

- Deviations higher than permitted resulting in change of load scheme on anchors (shear) and increasing the displacement (because of big clearance under the anchor head).

- Lack of quick drainage of water from the area of works resulting in changes in its consistency, which leads to reduction of soil resistance and change of static scheme of retaining wall.

Moreover, the monitoring system was completely chaotic and unreliable: the targets were localized on thin bars what made it vulnerable, the measurements started too late, load indicators were installed at the anchors two stages after they started working (therefore the anchors were firstly relieved and the indicator measured an undefined increase in the load).

Fig. 3. View of the retaining wall with presentations of some of the execution errors.

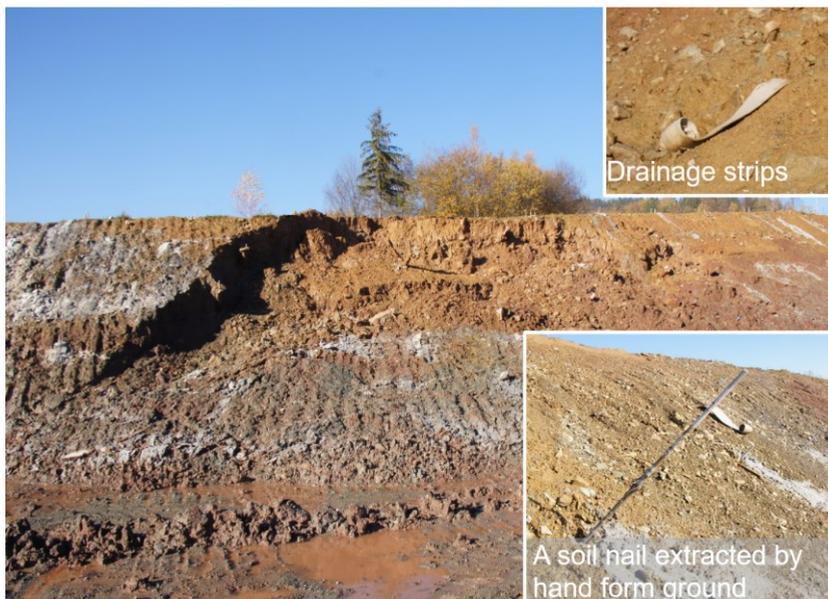
During the field inspection it was found that numerous landslides of different area and depth were formed (Fig. 4), some of the shallow slide character, some deep-seated. There were also many tension cracks above the slope visible, which testify to the progressing of geodynamic process. Significant number of groundwater outflows were also observed, liquifying the soil around and forming local slides.

Fig. 4. Landslide on the slope and detail of badly installed soil nails and improper drain technology.

Firstly, the soil nails were installed using the pre-drilling method instead of self-drilling as designed without proper modifications. Although both methods are acceptable, to be

regarded as equivalent special actions must be taken to obtain the same load bearing capacity despite lower skin friction [5] (cf. 0). Also, serious installation errors were revealed, resulted in no grout body formed, so the soil nails had almost no capacity (in the Fig. 4. Landslide on the slope and detail of badly installed soil nails and improper drain technology 6 m long soil nail extracted from the ground by bare hand (!) is shown). Furthermore, the soil nails chosen by the contractor had smaller load capacity and flexural stiffness than specified in the project.

The drains were described in the tender as a perforated drainage pipe placed in the borehole, protected with geotextiles, while the contractor used drainage strips introduces directly into the ground without the pipe, which shows incomparably worse draining effect of the rock mass, significantly worsening geotechnical conditions. This fact is exceptionally meaningful, as the regulation of water relations has a critical impact on slope stability, as well as maintenance costs and aesthetics.

According to the design and appropriate standard [5], the slope was to be formed with a top-down system in stages: excavation to the depth of the working level (soil nail row), soil nail installation (and drainage if applicable), fixing the facing. Actually, this sequence was disturbed, as the contractor carried out earthworks to the depth of as many as five working levels, and only then installed soil nails on (as evidenced by the very uniform traces of an excavator bucket visible in the photograph, cut through with later installed soil nails). In addition, the contractor did not install the facing system, which is critical for the cooperation of the nails and the surface stability. Undoubtedly, this procedure contributed to degradation of the stability conditions.

Additionally, as there were no surveying or geotechnical monitoring reports and no target were noted on site, it means none monitoring programme was conducted by the contractor. Also the contractor had not reported that ground conditions were significantly different than assumed in the design. The dominant layer was highly weathered shales, extremely worsening the shear resistance in contact with water, what in the situation of lack of the properly working drainage system caused serious change of the assumptions of static and stability calculations.

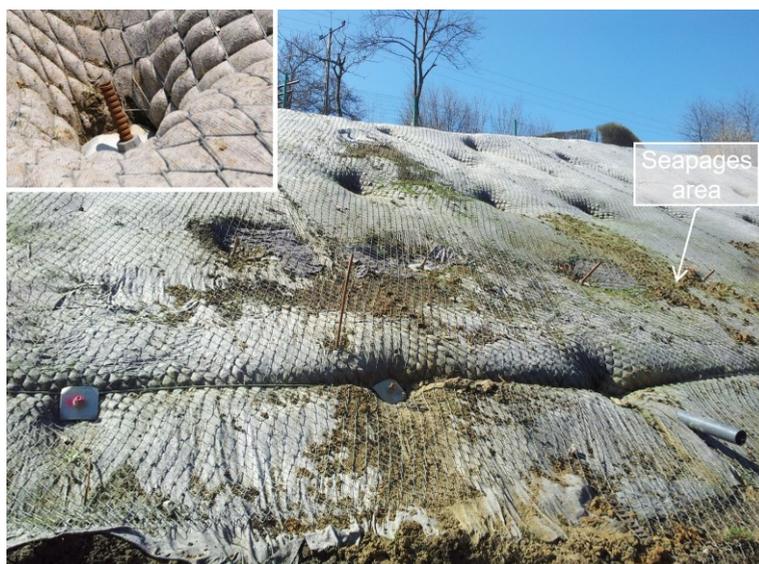
The geotechnical designer has been informed about the difficulties at the site when first soil nails started to break. The inspection onsite revealed severe problem with overall stability at one section of deep cut of a length of app. 60 m. The excessive displacements of the slope were clearly visible. Within this section, all elements of structure were obviously overloaded – the nail heads had been sunk (sucked) into the ground, app. 40-50 cm below slope face (Fig. 5). In several points the hollow bars were broken, as well as single eyes of the steel mesh.

Despite significant displacement (the slope base line intruded far beyond the road perimeter) and single element failures, the construction still has been resisting, holding up the ground masses. In general, the construction behaved as monolithic retaining structure, that moves as a one block. Luckily, the concept of nailed structures as inner reinforcement of ground mass, proved its correctness. The structure has been deformed but still able to hold up itself without inner failure and hold up all infrastructure above deep cut: houses and road, intact. Further inspection revealed that soil conditions were significantly worse than described in geological report and encountered at other sections of deep cut. The areas of increased moisture were easily observed at the slope face. The soil itself, coming out of breached facing, was almost liquified. Further, no drains were installed within the slope, except the ones of basic layout.

Fig. 5. General view of the deformed slope with detail of the overtensioned soil nail and steel mesh.

Although the reasons of failure have seemed to be obvious, the material tests were commenced. The samples of hollow bars and steel mesh were taken to prove declared values of tensile strength. All tests were positive. Rejecting the influence of any deficiency of reinforcement (nails and mesh), the reason of failure was clear – soil conditions far below the ones, that have been taken into stability calculations. As in terms of lithology the soil has not differed from expected, the excessive moisture has been pointed as a source of the problem. This was due to lack of additional drains, that could have taken increased inflow of ground water to this section of deep cut.

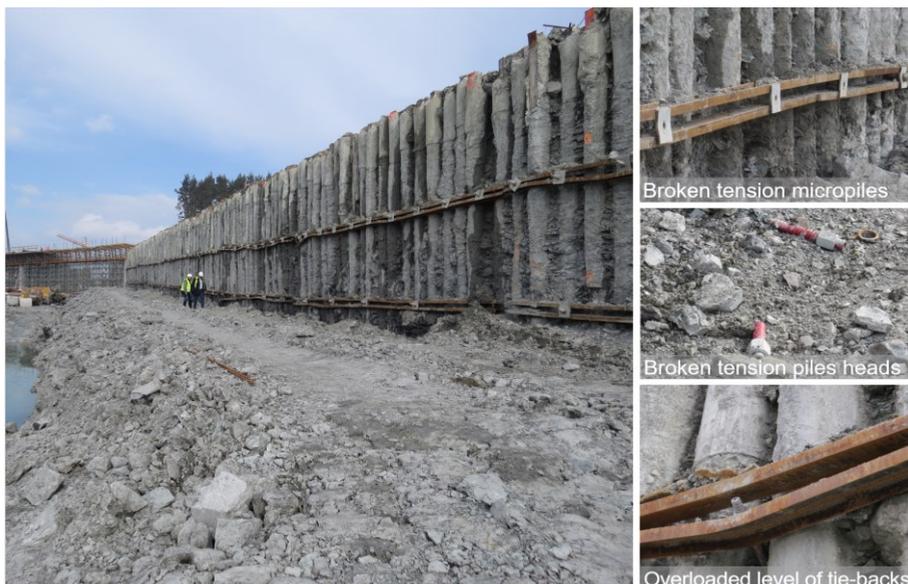
Shortly after excavation below second level of tie-backs, the tension micropiles within second level started to break (Fig. 6). The subcontractor replaced broken micropiles with new ones, which in some cases also failed. The wall started to lean towards the excavation. Reaching the level of layer three (the last one) of tie-back turned out to be impossible. The crown displacements of the wall were increasing rapidly, reaching 87 cm (!) at the worst phase. This failure caused increased load onto micropiles and construction within the first level. In such conditions, the surveyor together with the designer decided to halt all further works and support the structure with emergency ground abutment. The excavation has been filled back to the 1/3 of its current height, which is up to the first level of tie-backs (2/3 of the excavation depth was filled back again). After thorough research on failure reasons, the repair design has been implemented with replacement construction. There was no possibility to save and use the former one, or even its single elements.

The tensile test results (trial loads) of micropiles have shown, that several tension micropiles have reached only 20% of their design load. Next, the independent laboratory tests have shown, that hollow bars used do not reach their declared values of safe working load. Finally, the piles that were laid open after the repair construction has been done, revealed several imperfections – some of the piles were shorter than designed, some of them didn't have continuous concrete body and some had totally exposed reinforcement at lower section, completely without any concrete. This mixture of poor quality of works and materials used have created a huge lack of required strength, as well as strictly chaotic distribution of loads within entire construction.

Fig. 6. General view of the construction with emergency abutment and details of damaged elements.
