Excavation support – geotechnical failures in the context of design and execution errors as well as formal and economic conditions

Natalia Maca^{1,*} and Jakub Sierant¹

¹TITAN POLSKA Sp. z o.o., Miłkowskiego 3/801, 30-349 Kraków, Poland

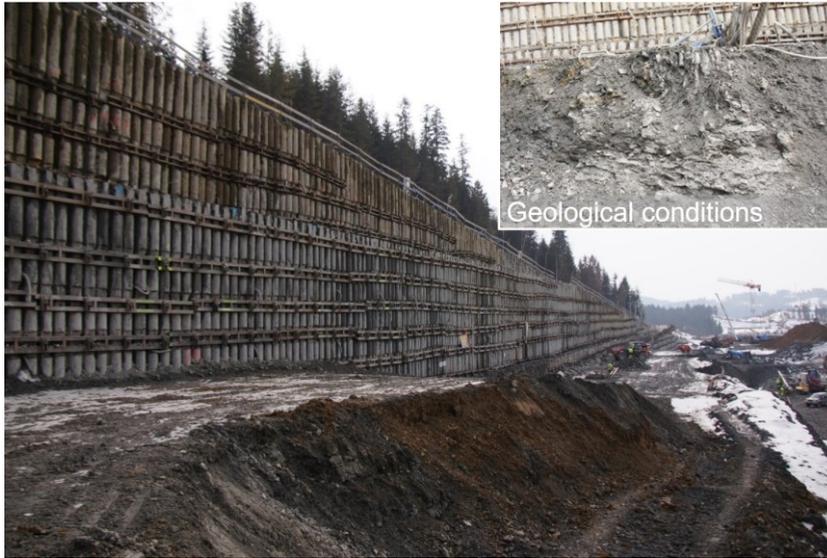
One of the retaining structures along the new express route, of length nearly 300 m and the maximum height 30 m has been designed as a sequence of three parallel anchored pile walls formed (Fig. 2). The pile wall has been made of DFF Ø40 cm piles in spacing of 50 cm with reinforced concrete facing. In the DFF technology a pile is firstly drilled with continuous flight auger, cased. Then, after reaching some harder base, the auger is withdrawn and the remaining length of a pile is drilled with down-the-hole-hammer. The H beam has been used as a pile reinforcement. The wall has been anchored with tension micropiles of capacity up to 970 kN and length up to 36 m in several rows, depending on the height. The project also provided drill drains system.

In terms of geotechnical conditions the weathering profile of Carpathian flysch rocks has been presented, mainly shale and sandstone squeaky rock material (with a significant predominance of shale) strongly tectonically deformed, with numerous weaknesses and discontinuity zones. Deeper layers showed clear moisture and shallow underground water levels have been found and local leakage of spring outflows form. The area has been classified as a landslide region. Due to the high unpredictability of ground conditions reported in the indicated area and required reliability of the retaining wall the project was to be executed within the observational method.

Fig. 2. General view of the retaining wall with ground conditions illustration.

Site visit revealed that project has been executed without the use of observational method, what means without ongoing adaptation of the solution to the actual geological situation assessed continuously and failing to comply the design provisions. The analysis of the situation showed that contractor changed the technology and sequence of operation, what influenced negatively not only the serviceability of the retaining wall, but also gave doubts about its bearing capacity. Some of contractor's arbitrary changes and errors (Fig. 3):
